DEPARTMENT OF TRANSPORTATION**DIVISION OF ENGINEERING SERVICES**

Contract #: 04-0120F4Cty: SF/ALA Rte: 80 PM: 13.2/13.9File #: 69.28**WELDING INSPECTION REPORT****Resident Engineer:**Siegenthaler, Peter**Address:** 333 Burma Road**City:** Oakland, CA 94607**Report No:** WIR-019688**Date Inspected:** 19-Jan-2011**Project Name:** SAS Superstructure**OSM Arrival Time:** 700**Prime Contractor:** American Bridge/Fluor Enterprises, a JV**OSM Departure Time:** 1900**Contractor:** Zhenhua Port Machinery Company, Ltd (ZPMC), Changxing Island **Location:** Shanghai, China**CWI Name:** Mr. Xu Le Feng.**CWI Present:** Yes No**Inspected CWI report:** Yes No N/A**Rod Oven in Use:** Yes No N/A**Electrode to specification:** Yes No N/A**Weld Procedures Followed:** Yes No N/A**Qualified Welders:** Yes No N/A**Verified Joint Fit-up:** Yes No N/A**Approved Drawings:** Yes No N/A**Approved WPS:** Yes No N/A**Delayed / Cancelled:** Yes No N/A**Bridge No:** 34-0006**Component:** Tower and Orthotropic Box Girder (OBG)**Summary of Items Observed:**

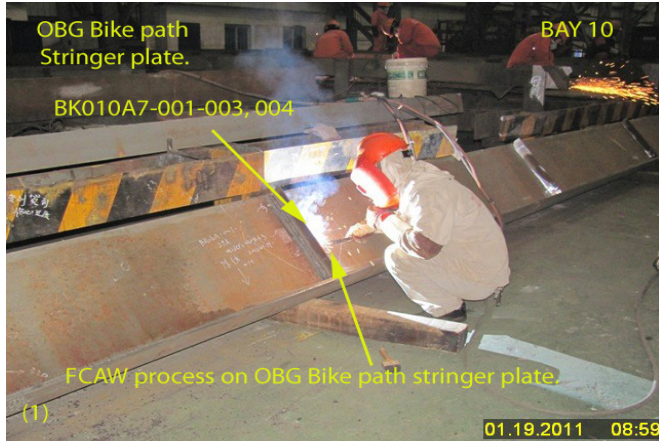
This QA Inspector observed ZPMC qualified welding personnel identified as 040533, Perform Flux Core Arc Welding (FCAW) on OBG Bike Path Stringer plate. Joint identified as BK010A7-001-003, 004, ZPMC QC Identified as Yu Zhi Lai. The welding parameters as measured using QC's calibrated instrument appeared to be in general compliance with WPS-B-T-2133-ESAB. For more information see attached picture number 1.

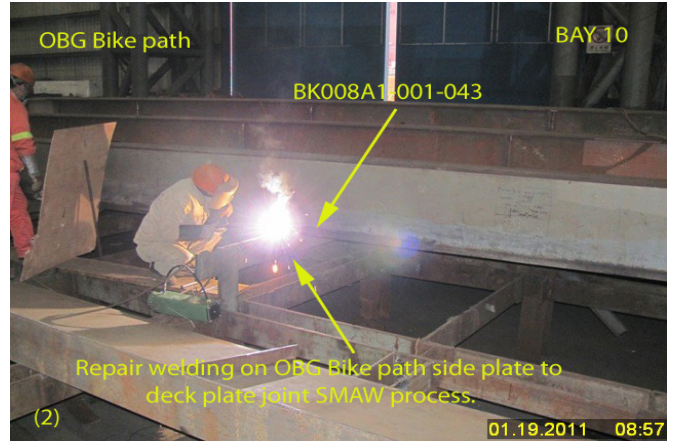
This QA Inspector observed ZPMC qualified welding personnel identified as 500363, Perform Shielded Metal Arc Welding (SMAW) on OBG Bike path. Joint identified as BK008A1-001-043. ZPMC QC Identified as Yu Zhi Lai with temporary welding repair report. The welding parameters as measured using QC's calibrated instrument appeared to be in general compliance with WPS-345-SMAW-2G (2F) Repair. For more information see attached picture number 2.
